A Report of A Survey of Traffic Vibrations and Their Probable Effects on the Crocker Art Gallery

October 1959

State of California
Department of Public Works
Division of Highways
Materials and Research Department

59-06

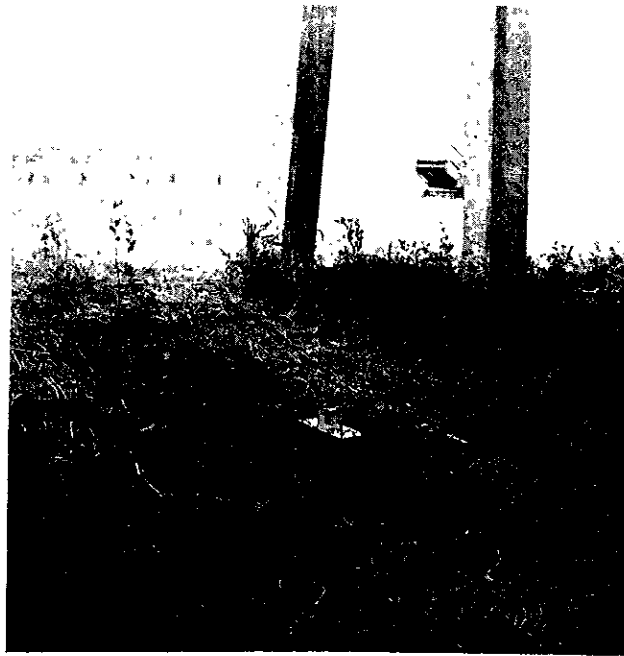
Location A: Yolo Causeway Vibration
Tester in the foreground.

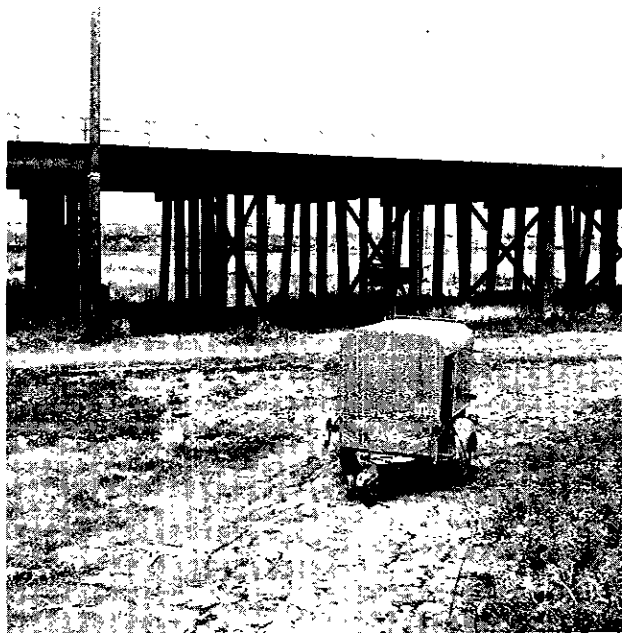
General view Yolo Causeway

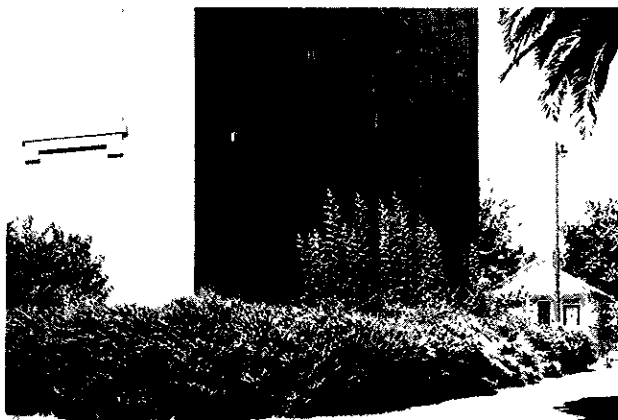
Crocker Art Gallery Annex

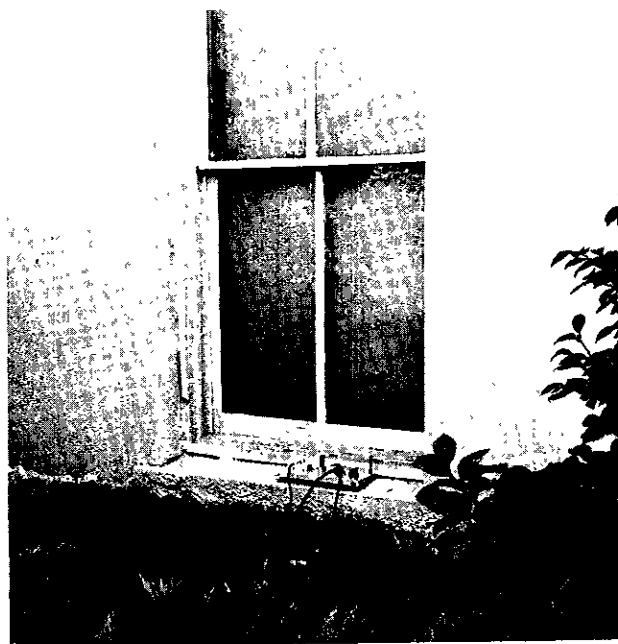
The vibration testers were then moved outside of the Gallery basement and set up to measure vertical, horizontal, and transverse vibrations on window sill 3. The location is J and is shown on Map III. The results show that the peak to peak displacement due to truck traffic is very small. The average displacement frequency was 100 cps. The higher frequency of vibration indicates that the displacement is due to air borne sound vibration shaking the instruments. The instrument vibration in this case is not due to earth borne vibration.

Measurable vibrations were recorded with our vibration testers on the outside basement wall of the Gallery Annex. These vibrations were due to air borne truck noises shaking the vibration testers. Displacements are small and in the order of 0.000004 to 0.00001 inches peak to peak. The average frequency was 100 cps.

Location J Window Sill #3
Vibration tester on window sill #3

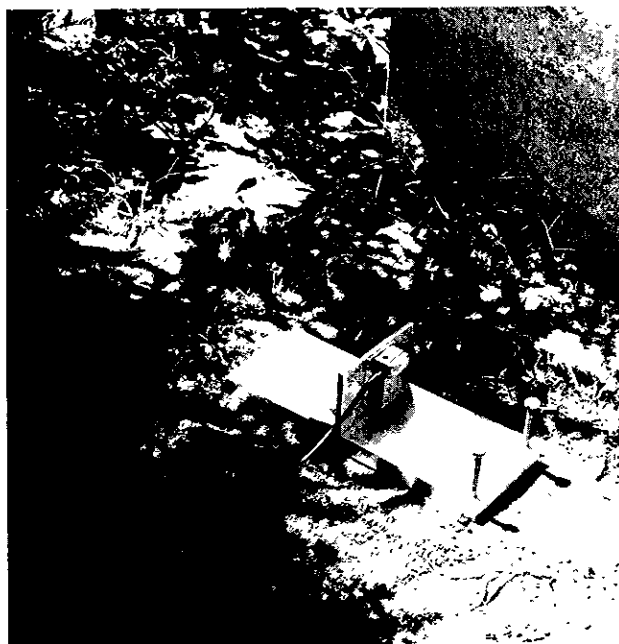
No measurable vibrations were recorded with our vibration testers on the ground at the two building corners of the Gallery Annex.

Location K: Vibration tester
at corner of building.

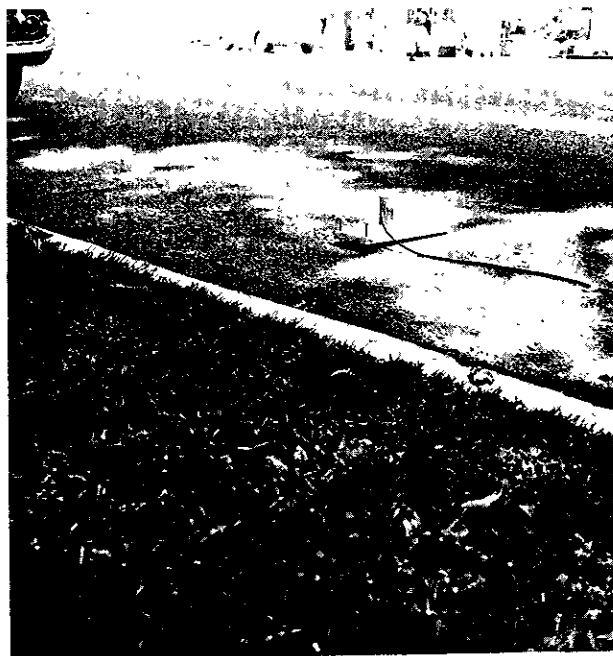
To measure the amount of earth borne vibration transmitted to Locations K, L, and N, vibration instruments were set up at the above locations to measure vertical displacements. As shown in Table III the measured vibrations due to truck traffic were of insignificant amplitude at the building corners. At Location N, one foot into the street from the curb, the displacement average was 0.00008 inches. The average displacement frequency was 22 cps.

Vibration measurements on 3rd Street show an average displacement of 0.00008 inches, peak to peak. The average frequency was 22 cps.

Location N: Vibration tester
on 3rd Street pavement.
